National Oceanic and Atmospheric Admin. NATIONAL OCEAN SERVICE Damage Assessment Center Florida Keys National Marine Sanctuary

SUBJECT: Class-Sea vessel grounding assessment report

FFWCC INCIDENT (CASE) #: 02-3A-3533

NAME & DESCRIPTION OF VESSEL: Class-Sea (DOC 941998), 48.6' Viking cabin vessel

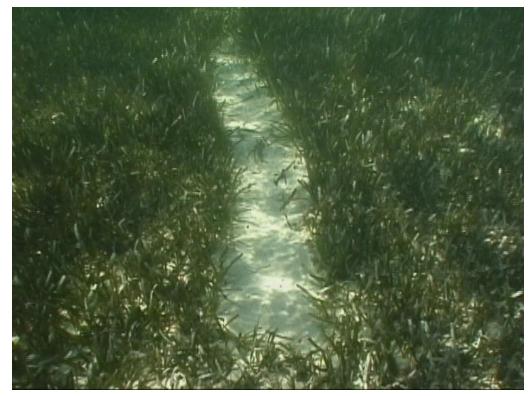
Figure 3. Photo of southeast propscar.

The grounding consisted of a set of twin propscars, three blowholes, a berm, and a single keel scar (see Figure 2). The twin propscars travel at approximately 30°T across the flat. The northwestern scar was 7.28 meters long with an average width of 0.375 meters. The southeastern scar was 4.05 meters long with an average width of 0.20 meters (see Figure 3). To the southeast of the twin propscars, the first of three blowhole starts. The three blowholes line up on a bearing of 113°T. The first blowhole has an area of 0.39 meters² with a depth of 0.47 meters (see Figure 4). The second blowhole has an area of 0.29 meters² with a depth of 0.25 meters. The third blowhole is the largest of the three with an area of 9.47 meter² (see Figure 5). The maximum depth measured in this blowhole was 1 meter below the surround seafloor (see Figure 6). The total volume of material excavated is calculated to be 4.69 meters³. The material ejected from the third blowhole created a berm burying an area of 37.73 meters² of seagrass (see Figure 7). Sods of seagrass were found inverted on the berm. These sods were correctly oriented and placed in the first and second blowholes in an effort to preserve the resource (see Figure 8). The survival of these sods is unknown as of the writing of this report.

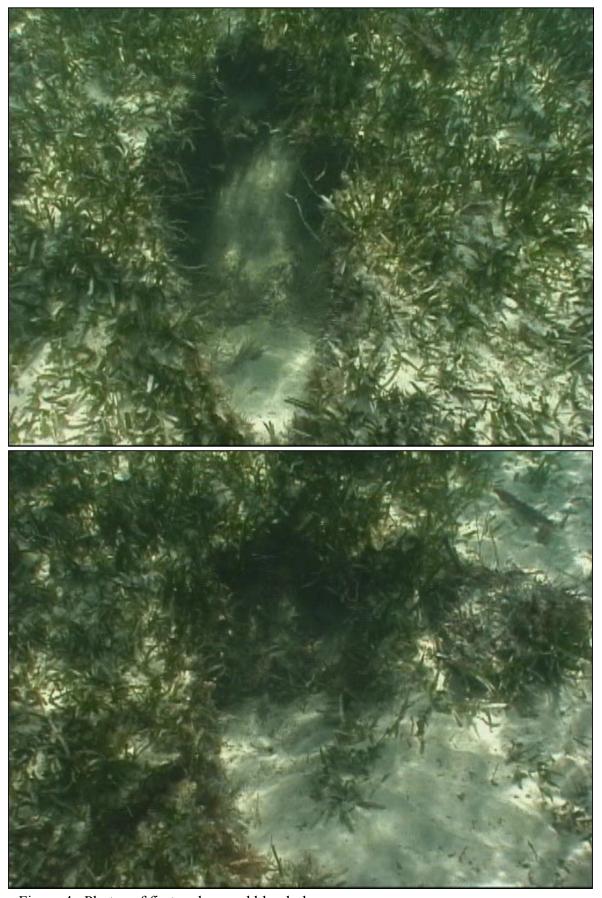
Figure 4. Photos of first and second blowholes

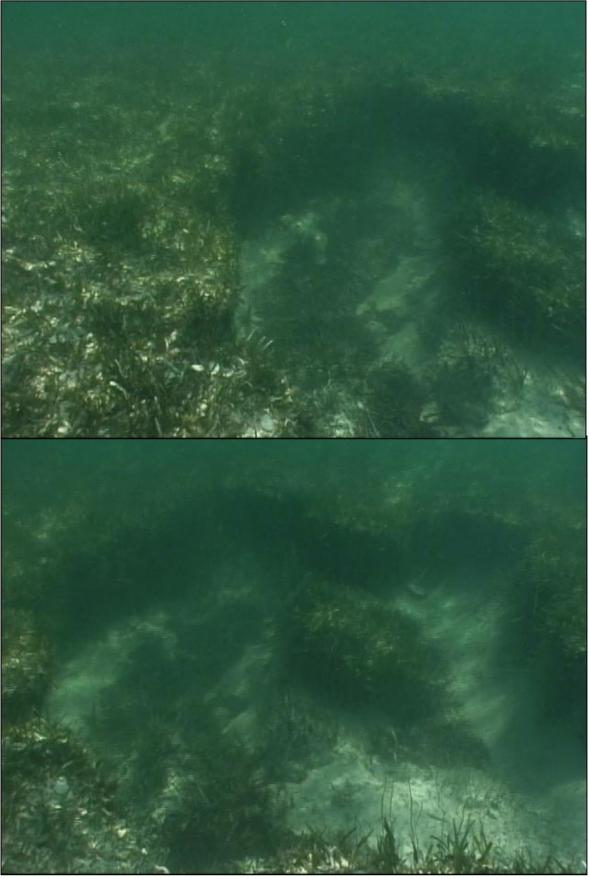
Figure 5. Photos of third blowhole.

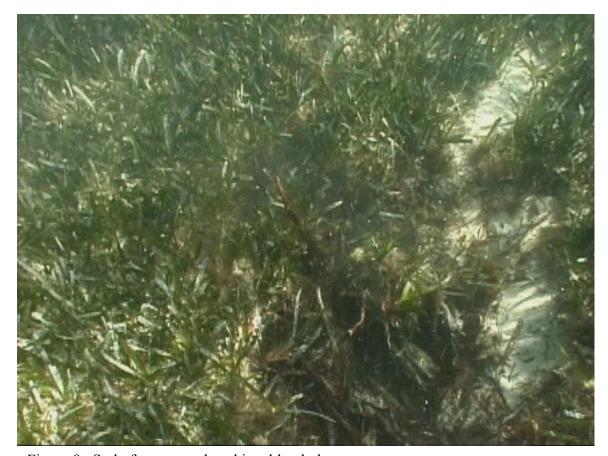
Figure 8. Sod of seagrass placed in a blowhole.
